**APARTMENT 16/ BAKERY**

**SWISS4LEBANON**

**Rebuilding Beirut** one house at a time

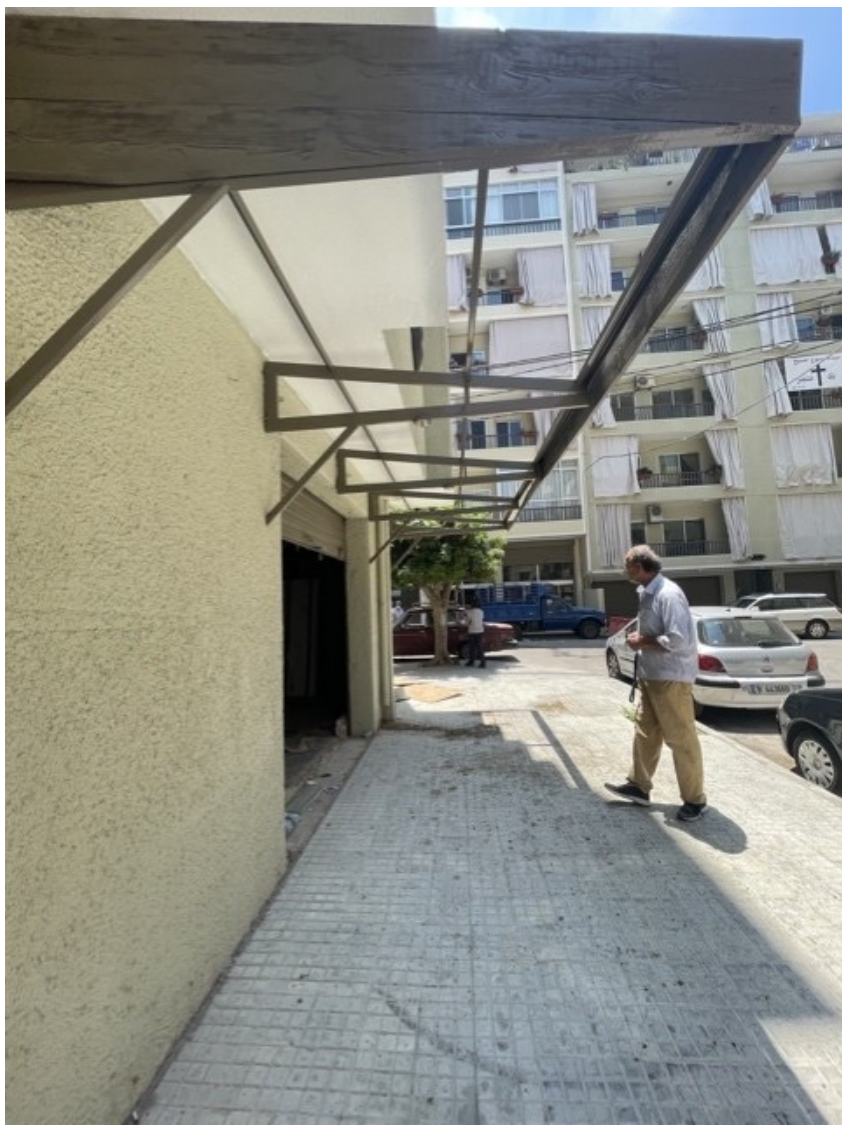
Outdoor Tent

- Two facades need aluminum and glass replacements.
- The ceilings need to be painted.
- The two outdoor tents needs some fabric repairs.

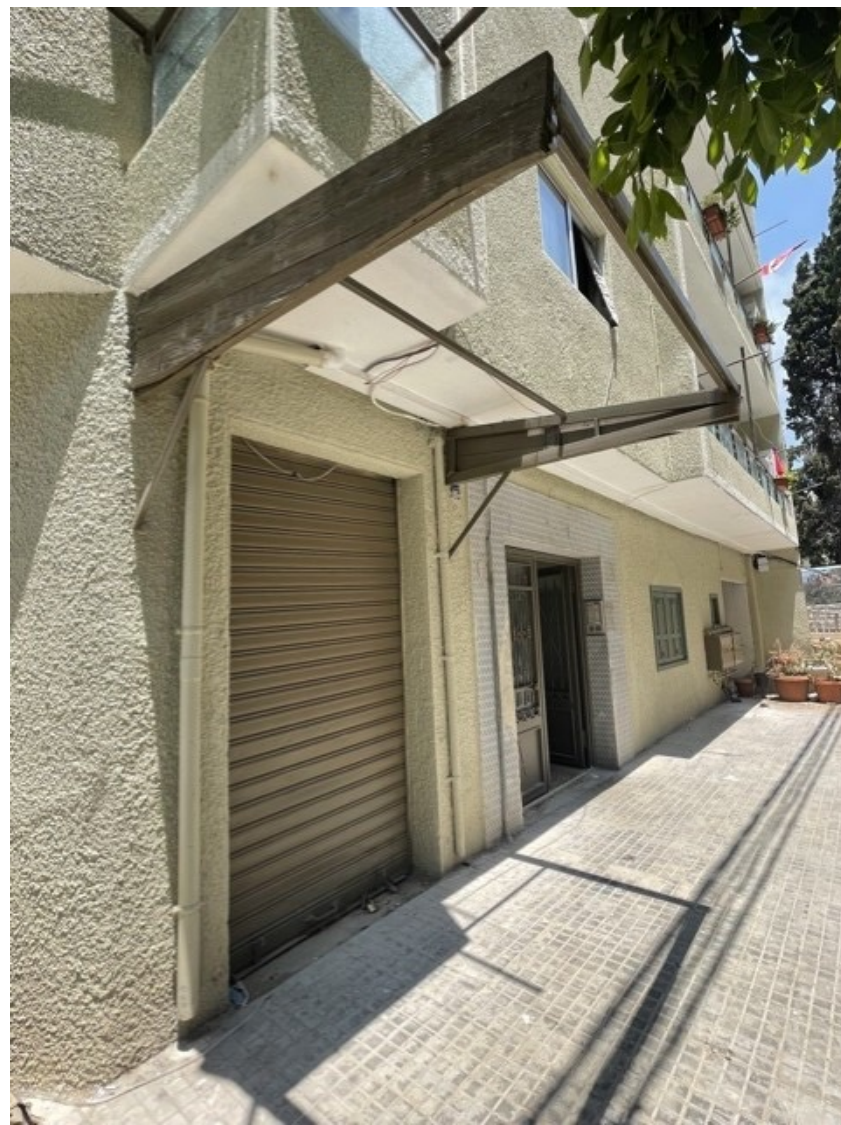
Outdoor Tent 2

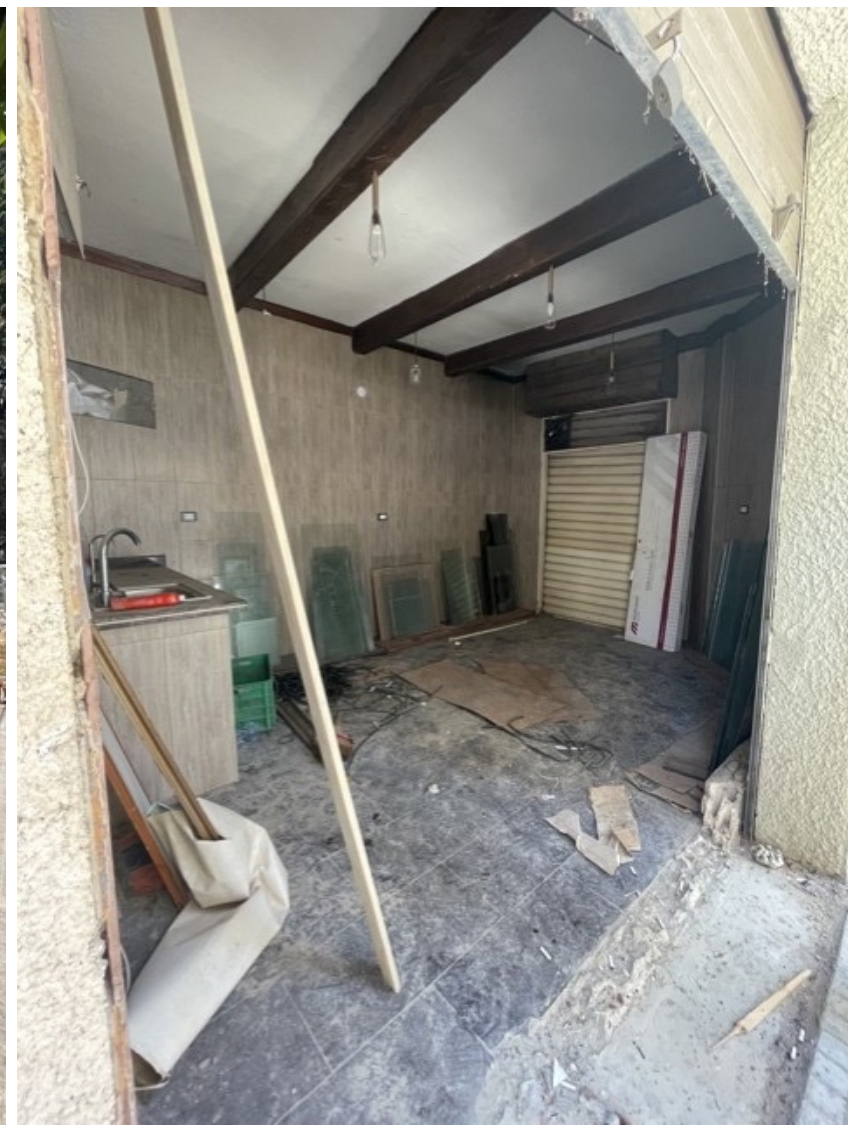
Bakery Main Facade

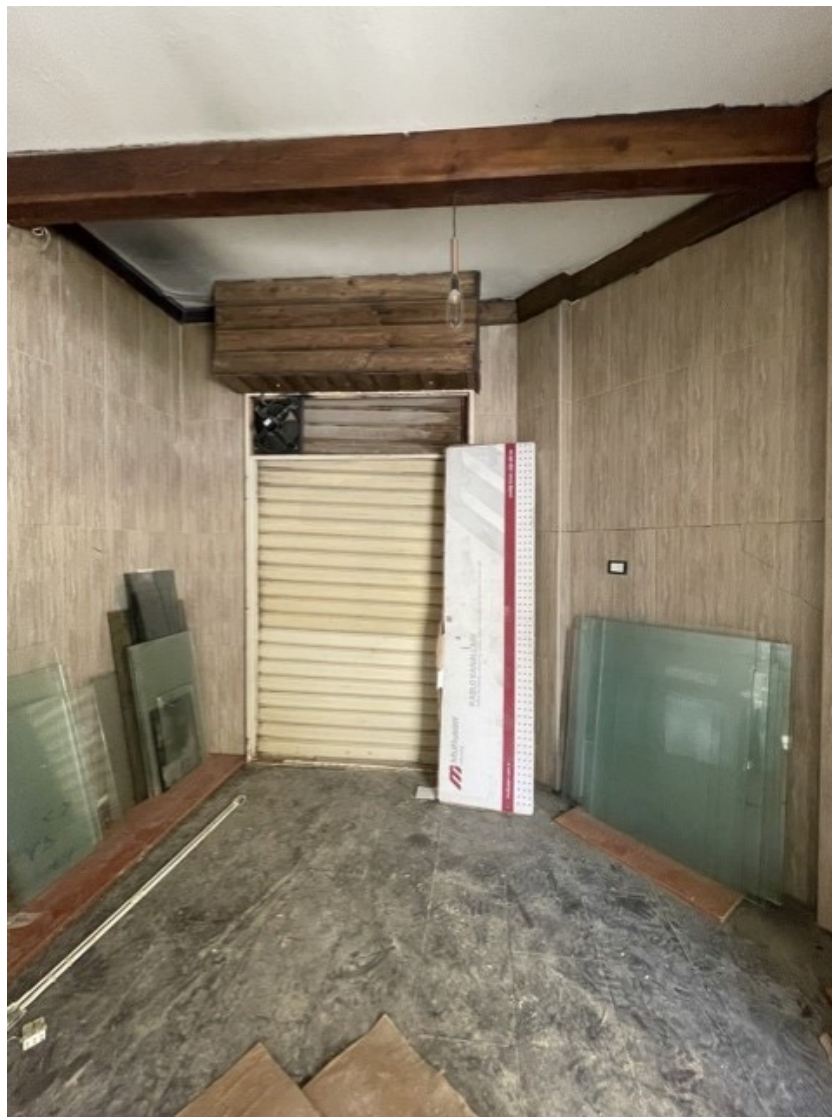
Entrance door

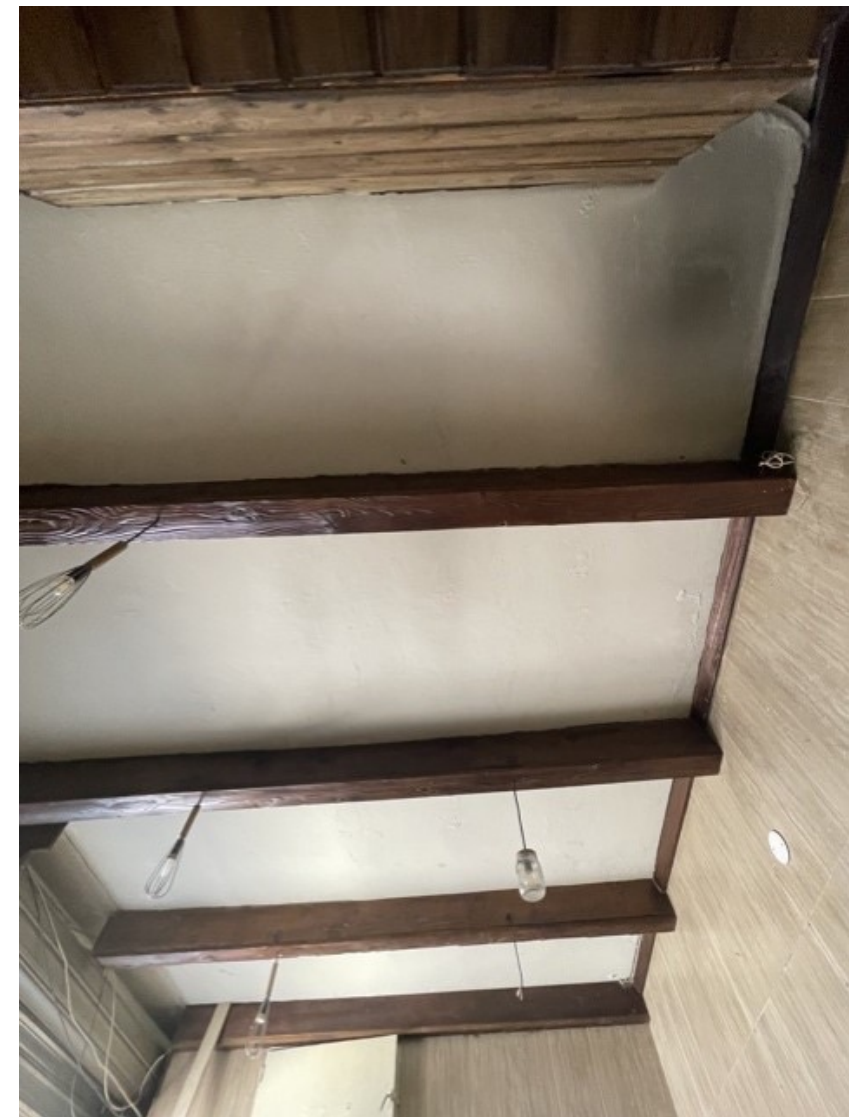
ceiling

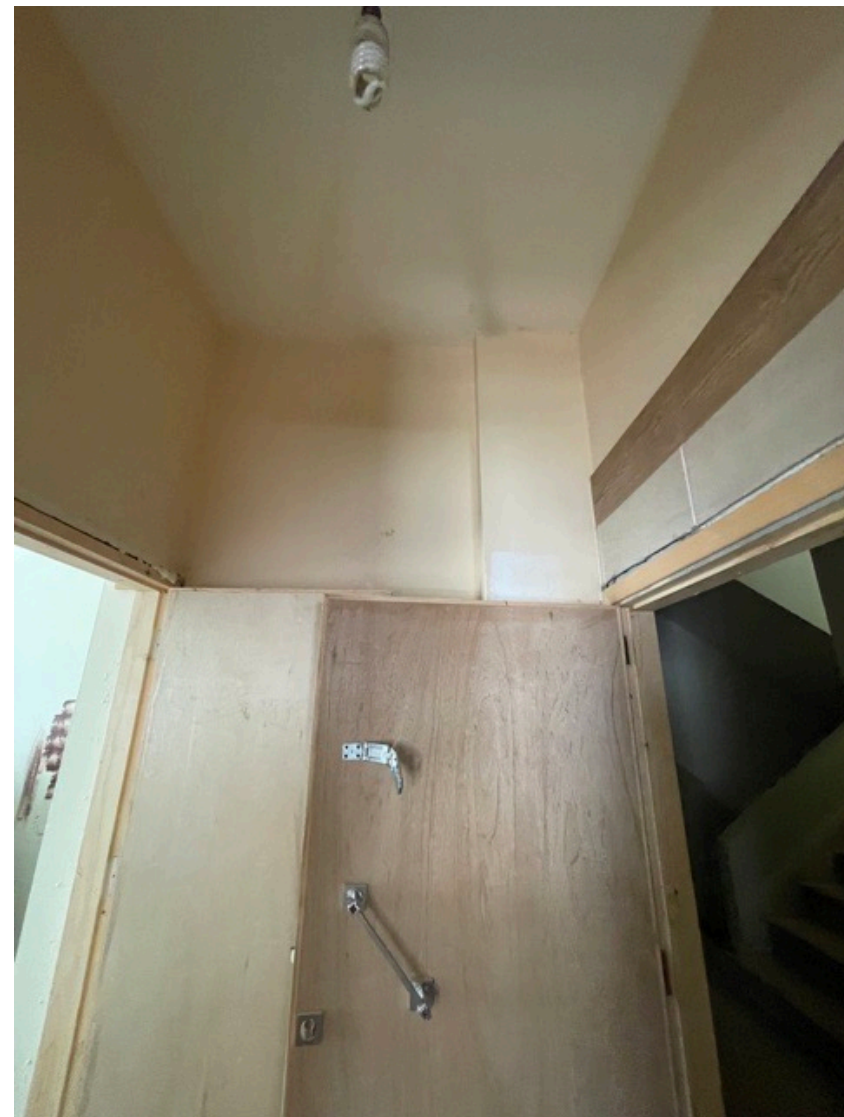
Main entrance

- Main entrance external and internal wooden doors needs to be repaired.
- Paint needed for the entire apartment.
- Bathroom needs sanitary fixtures. 1 fiber door and water heater tank need to be replaced.

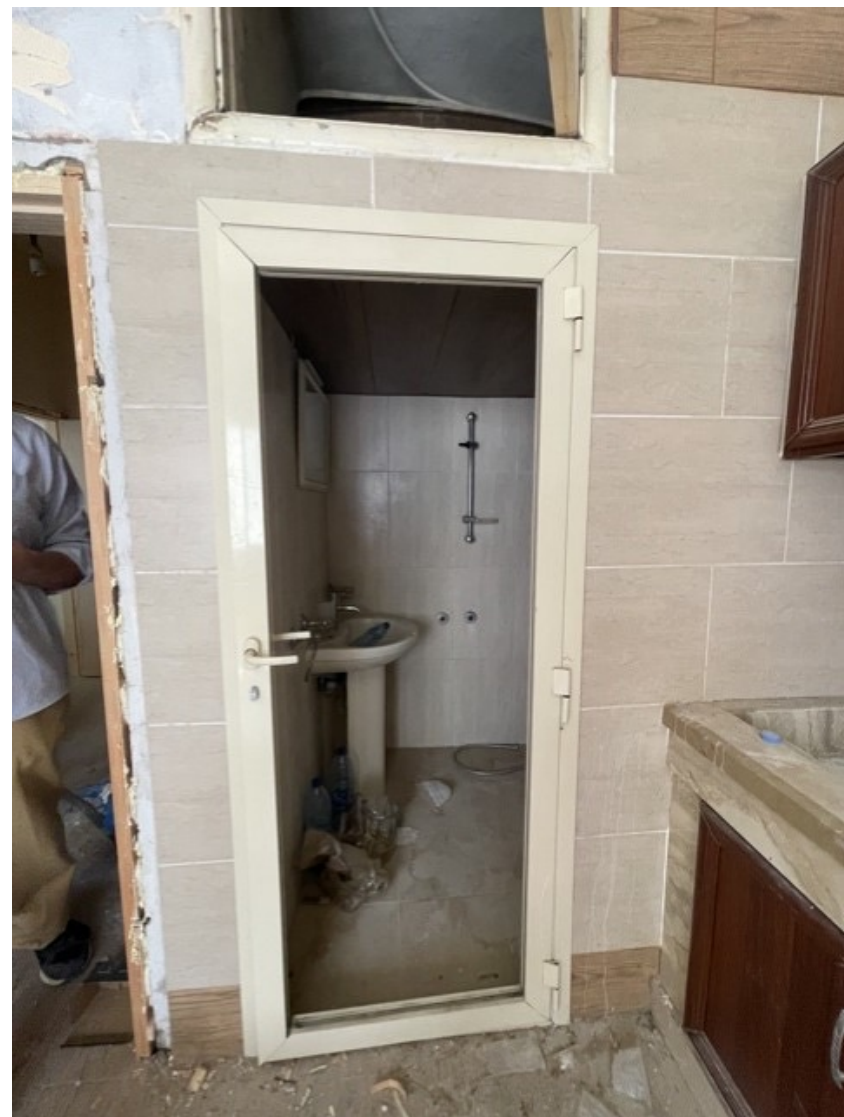
Bathroom fiber door
