# SWISSALEBANON Rebuilding Beirut one house at a time

**APARTMENT 2**

Area: Beirut, Geitawi

#### Damage Assessment

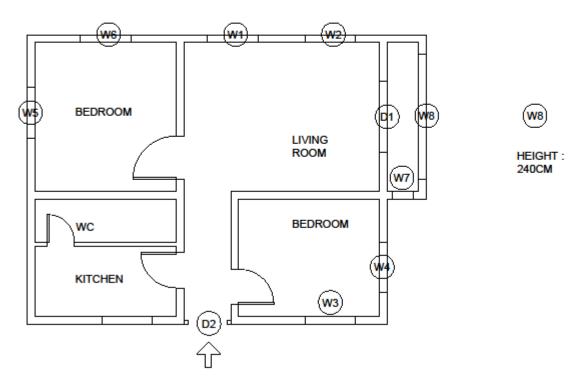
- Affected but habitable

- Broken windows and doors
- Damaged terrace area
- False ceiling destroyed

- Safe
