APARTMENT 4

SWISS4LEBANON

Rebuilding Beirut one house at a time

Damage Assessment

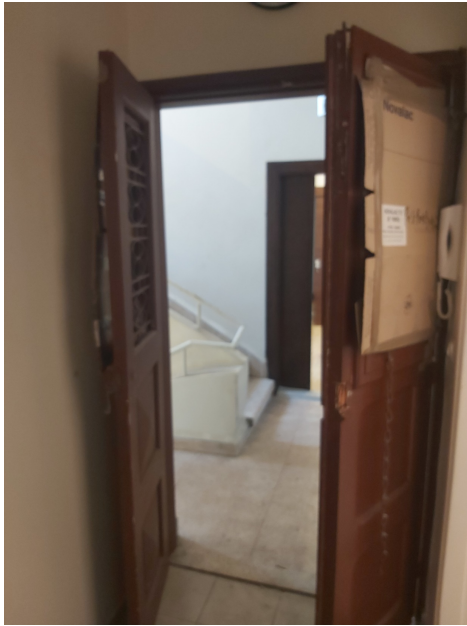
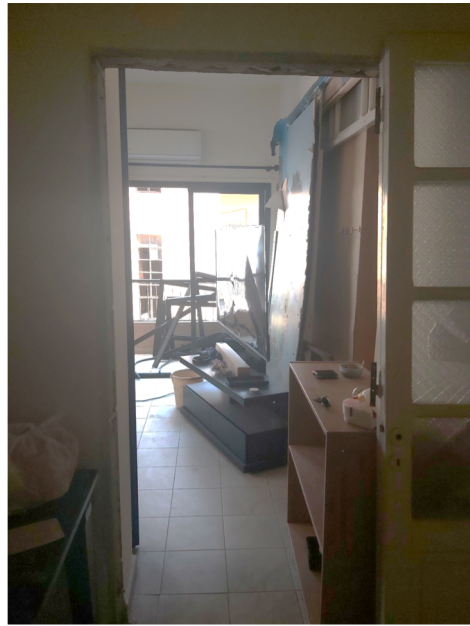
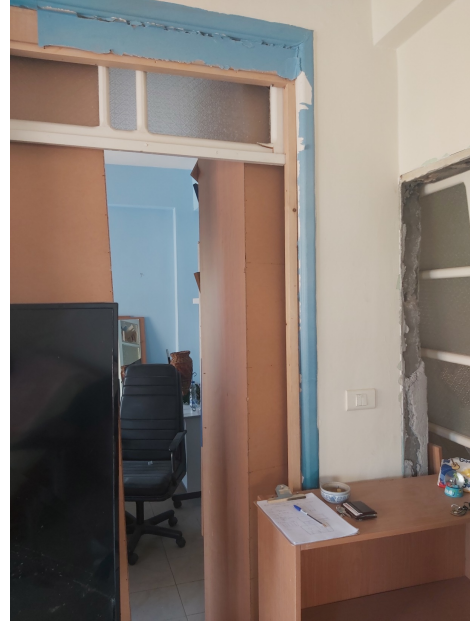
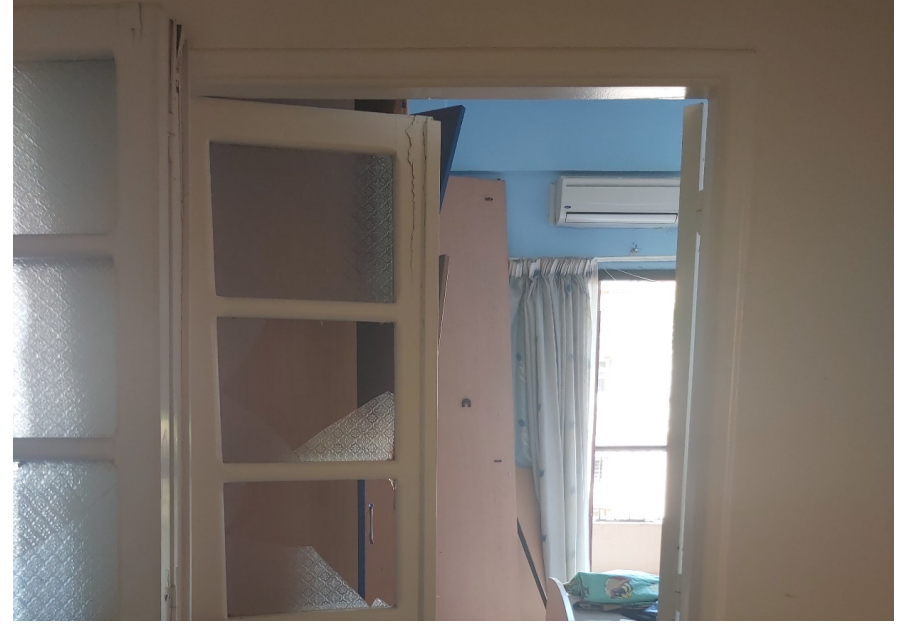
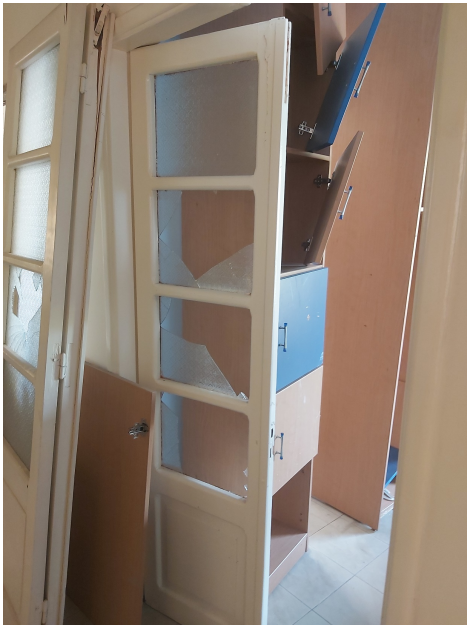
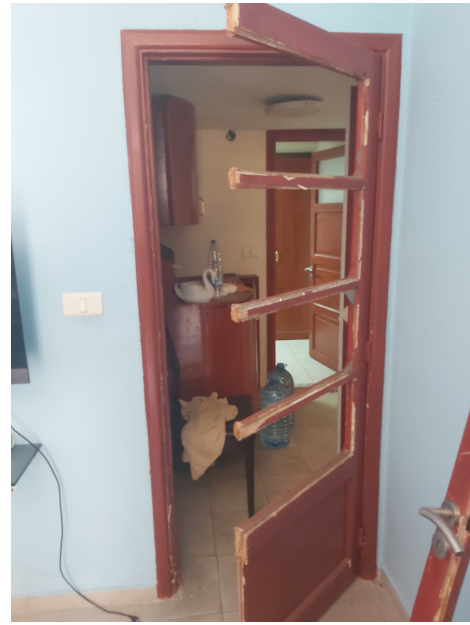
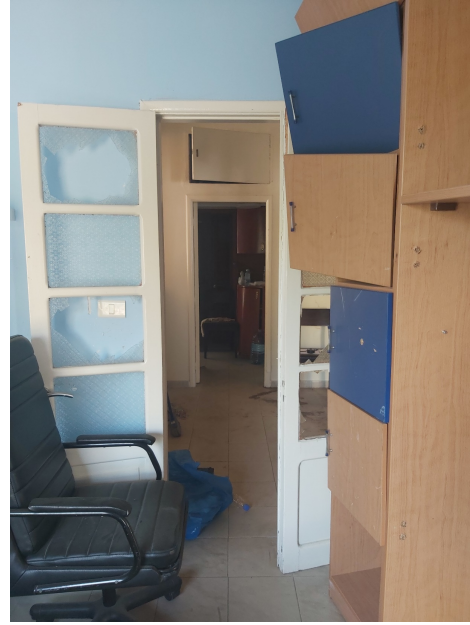
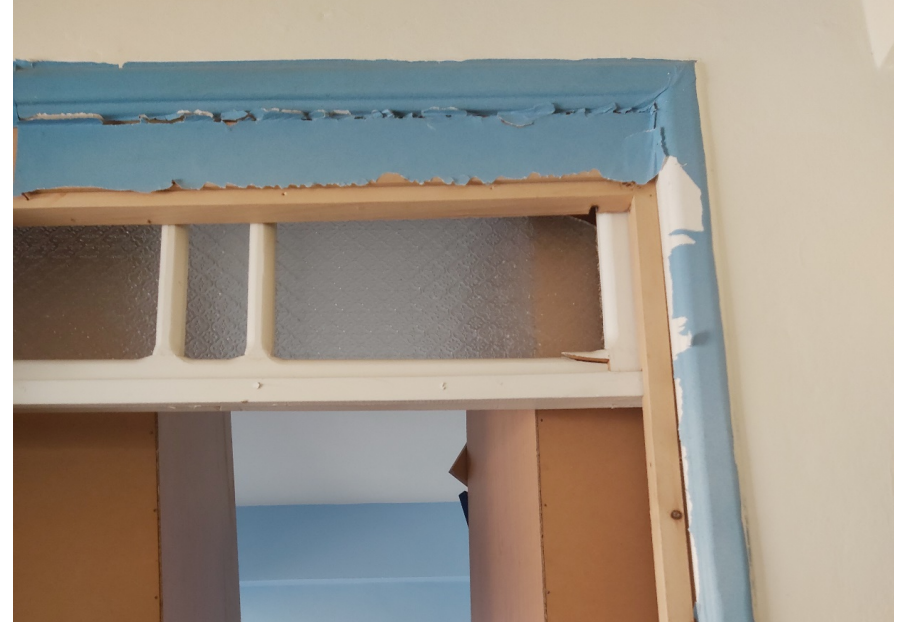
BEFORE

- Broken windows and doors
- Damaged terrace area

- Safe, requires maintenance to avoid leakage
- Damaged furniture
- Damaged bathroom

Divison	Type Of Work	Zone	Specifications	Qty.	Total Price (USD)
1	Metal/Glass Works				
1.1	Aluminium window				
	T1	BEDROOM 1	400 x 260 cm aluminum wall frame+sliding	1	1000
	D4	BEDROOM 2	145x207 cm aluminum wall frame+sliding	1	180
	D6	LIVINGROOM	160 x 207 cm aluminum wall frame+sliding	1	180
	T2	LIVINGROOM	255 x 275 cm aluminum wall frame+sliding	1	1200
				Total	2560
2	Wood Works				
2.1	Doors				
	D1	ENTRANCE	88 x 37 cm (plain glass for openings / no frame needed)	2	60
	D2	BEDROOM 1	80 x 192cm (frame needed)	1	200
	D3	BEDROOM 2	80 x 200cm	1	200
	D5	LIVING ROOM	210 x 115 cm	1	300
	D7	LIVING ROOM	254 x 254 cm	1	150
	ALL DOORS		Repair + Paint + Knobs	4	400
				Total	1310
3	Other Works				
	Paint		One layer of paint for most damaged walls		800
				Total	800
Sub-total					4670
Miscellaneous					400
Supervision Fees					500
Grand Total					5570
