APARTMENT 5

SWISS4LEBANON

Rebuilding Beirut one house at a time

Area: Beirut, Karantina,

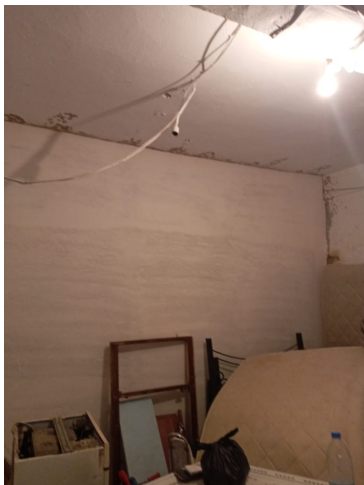
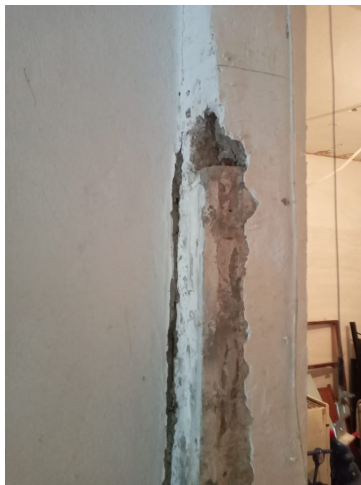
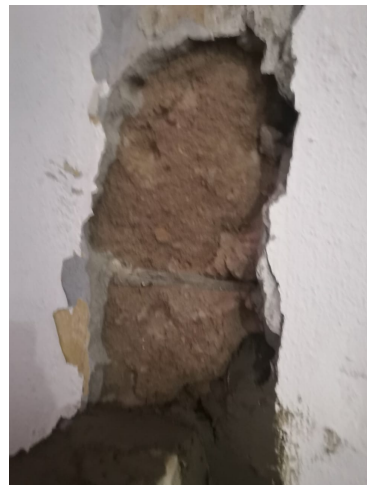
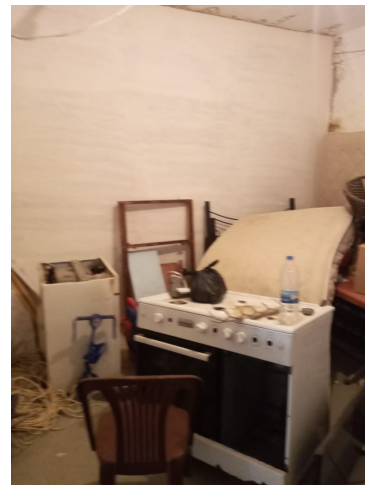
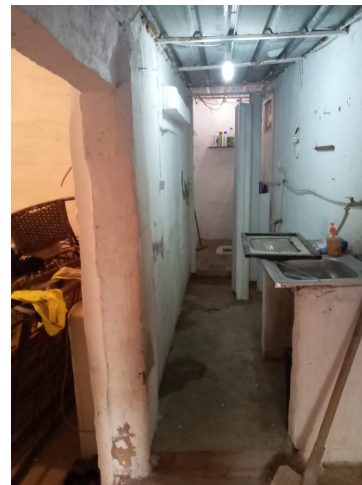
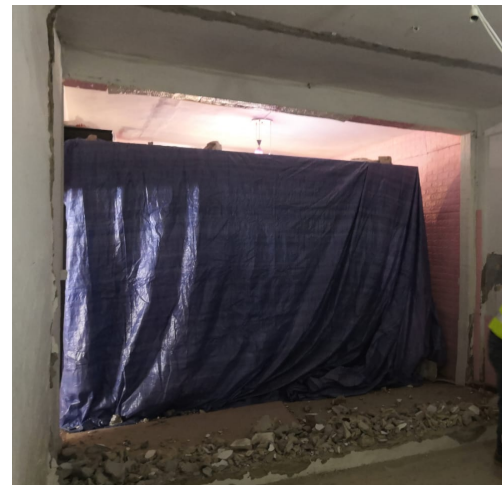
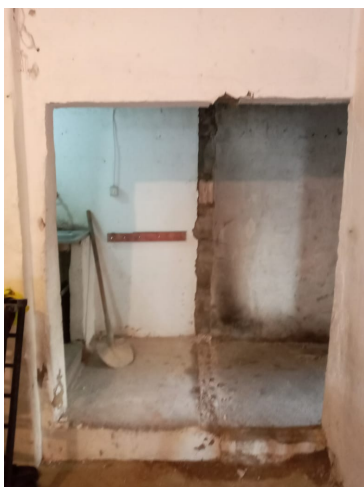
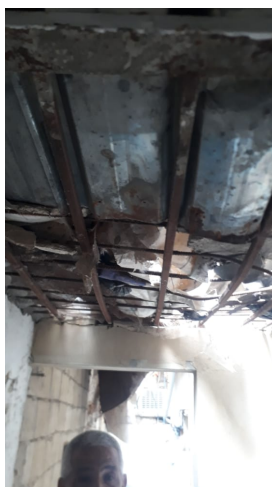
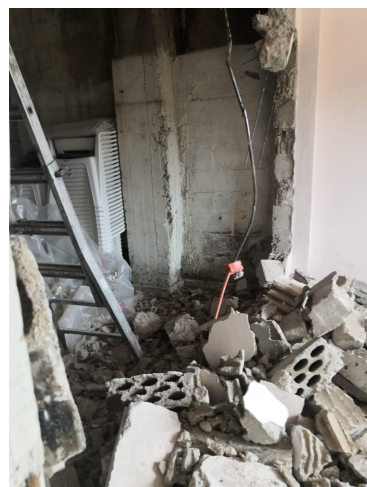
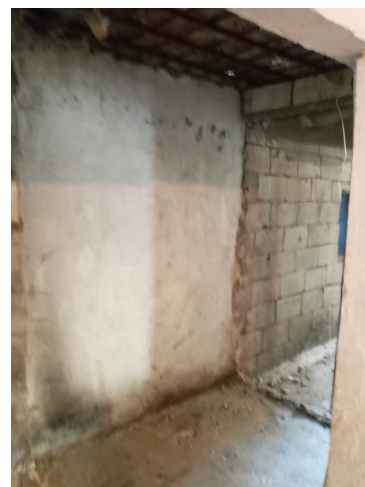
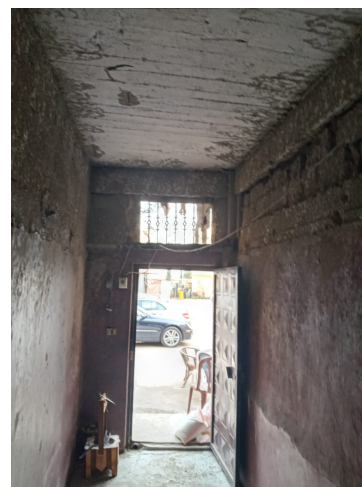
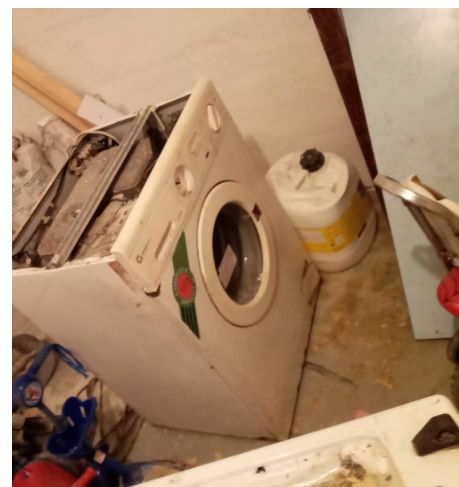
Damage Assessment / Before

- Affected but habitable

- Broken doors
- Damaged kitchen area
- Cracked floor
- Damaged electrical/plumbing fixtures

- Safe, requires maintenance to avoid leakage

Apartment 5		Khayriya Diab		
Type Of Work	Zone	Specifications	Qty.	Total Price (USD)
Tiling	Living Room	Floor (materials + labor)	40m2	1000
	WC	Walls & floor (materials + labor)	10m2	300
Civil Works	Corridor / Kitchen	Steel structure + Corrugated sheets + Labor	16m2	500
	Full House	Electric wiring + Fixtures		300
Paint Works	Full House	3 Layers of paint + Wall treatment (material + labor)		900
Plumbing	WC / Kitchen	WC fixtures + Sink		350
Furniture	Kitchen	3 Top cabinets + 3 Bottom cabinets + Sink		400
Sub-total				3750
Miscellaneous				450
Supervision Fees				400
Grand Total				4600
