APARTMENT 4

SWISS4LEBANON

Rebuilding Beirut one house at a time

Damage Assessment

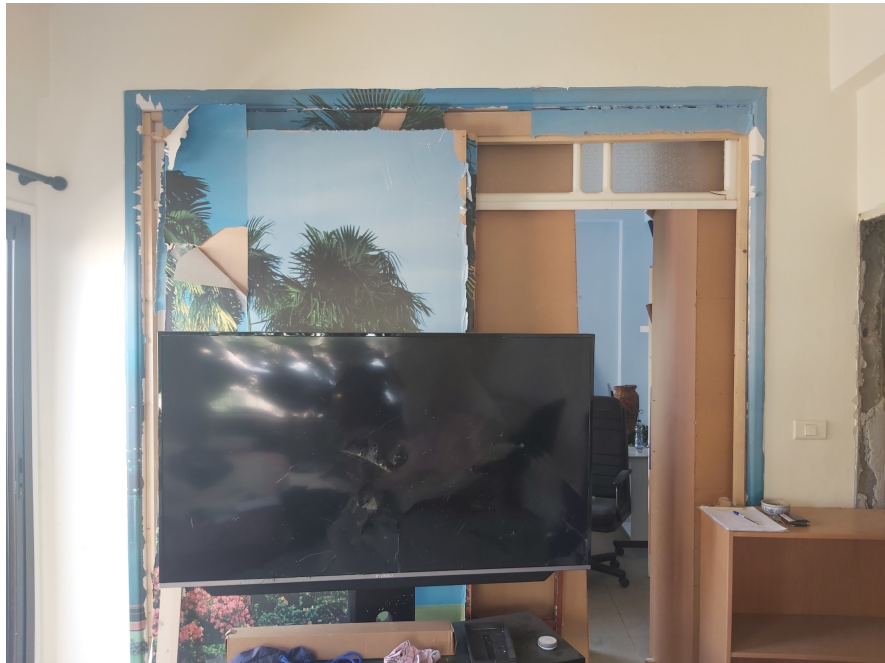
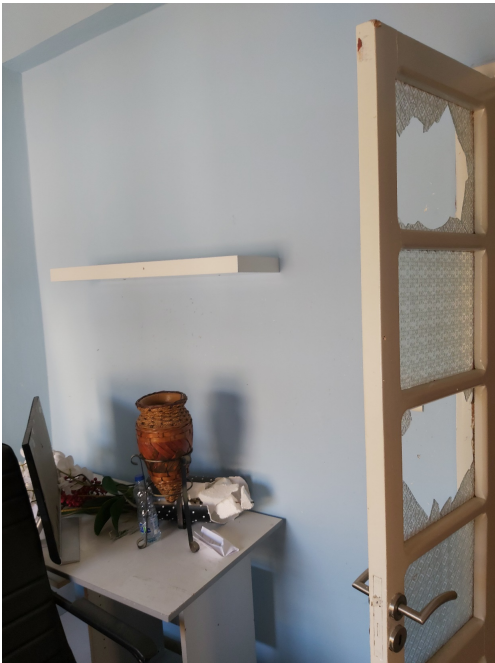
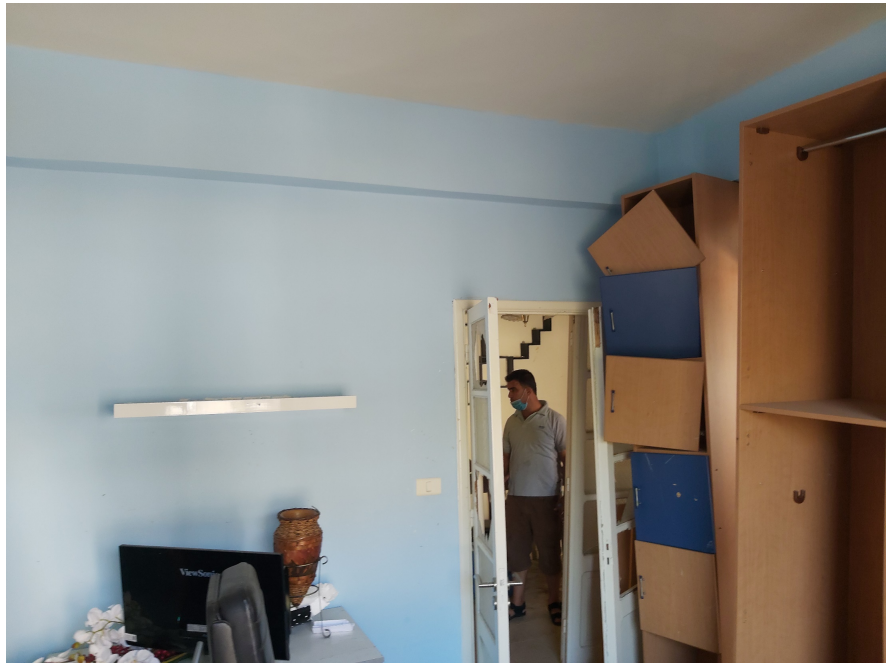
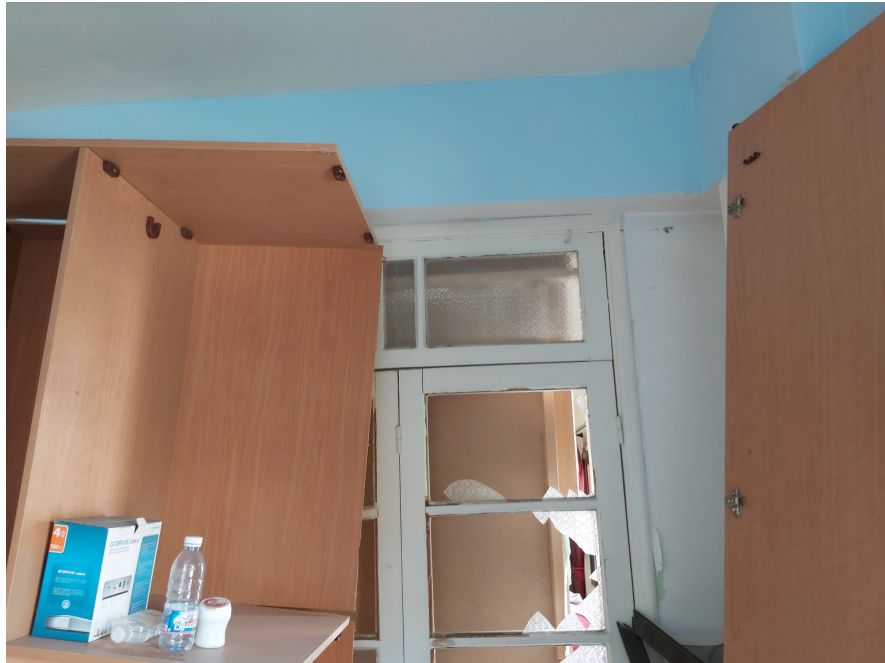
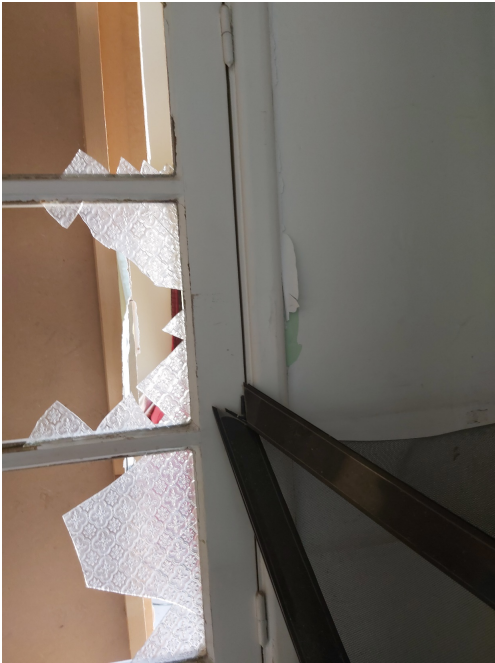
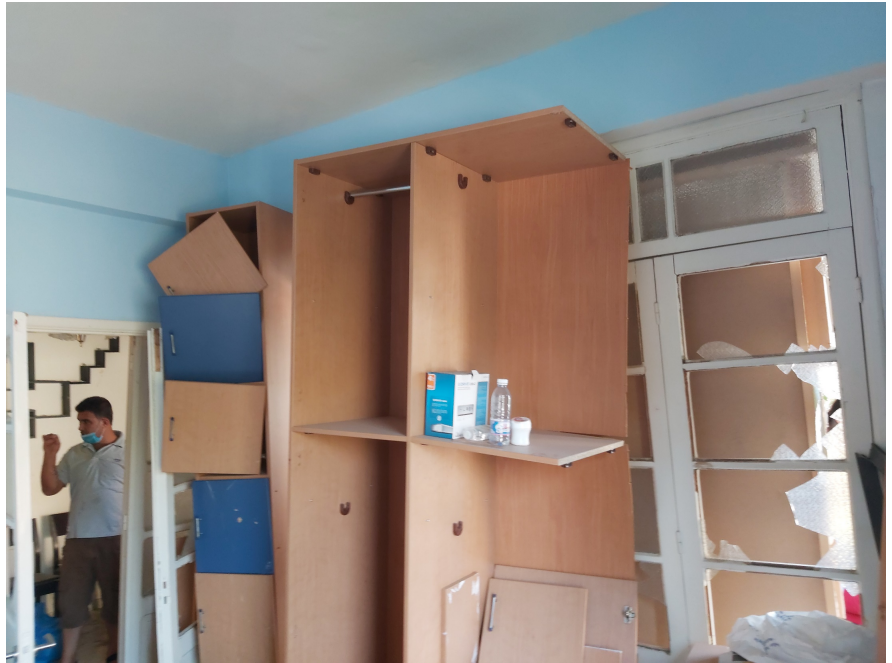
BEFORE

- Broken windows and doors
- Damaged terrace area

- Safe, requires maintenance to avoid leakage
- Damaged furniture
- Damaged bathroom
