Fires on ships Causes and preventive measures

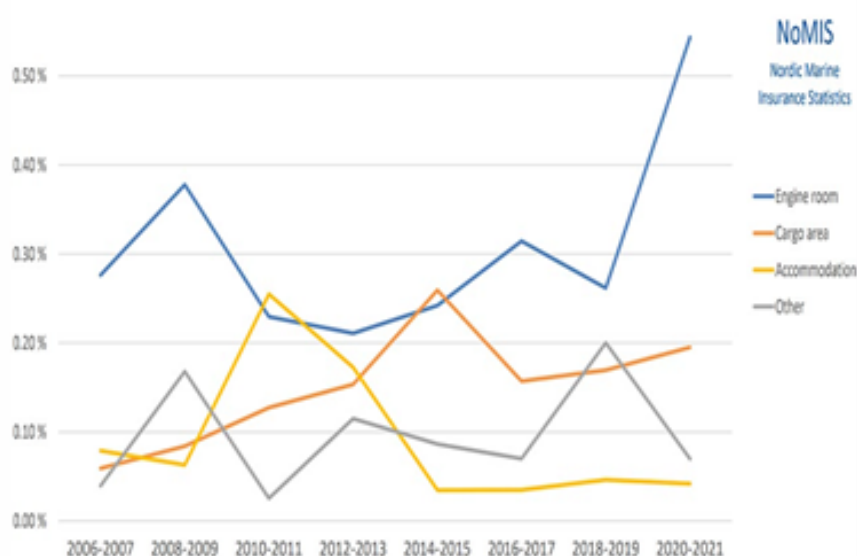
Chart Frequency of fire occurrence on container ships

An analysis by the Norwegian Association of Marine Insurers Cefor found that larger container ships are at a higher risk of fire with consequences that are difficult to contain due to their large size. Already in 2021, 70 fires were reported only on container ships over a period of 5 years. At the urging of the International Maritime Insurance Union IUMI, shipowners' associations and the flag states of Germany and the Bahamas, the IMO's MSC Maritime Safety Committee agreed in 2020 to amend the SOLAS Convention. The amendments will enter into force on January 1, 2028. The distinction between fires occurring in the engine room and those occurring in the ship's cargo storage areas as shown in the diagram is deemed necessary. Although fires in the cargo space of container ships show a steady increase during 2020 – 2021, the increase in the occurrence of fires in the engine room raises several questions that are critical to answer.
